Waterproofing Systems

Horizontal barriers against rising damp in masonry

issued: 04/2021

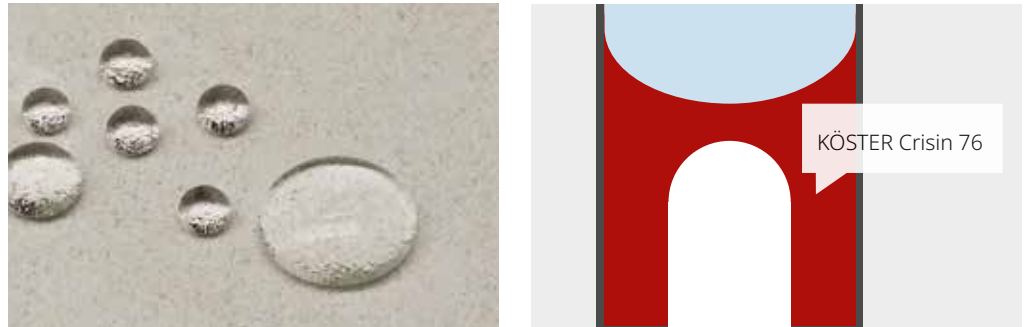
Hydrophobizing: Making the building material water repellent

Narrowing/blocking the capillary, forming an elastic film in the capillary

There are two fundamental ways to stop rising damp: Blocking capillary active pores or hydrophobizing their structure. Hydrophobizing the surface of a pore means to modify the surface tension so that it becomes water repellent (hydrophobic). Thus, the capillary action of that pore is stopped. Blocking a pore means to partially or totally fill the pore in order to stop the transport of water. It is crucial to bring enough material into the pore so that the diameter of the pore is narrowed far enough that no more capillary action can take place.

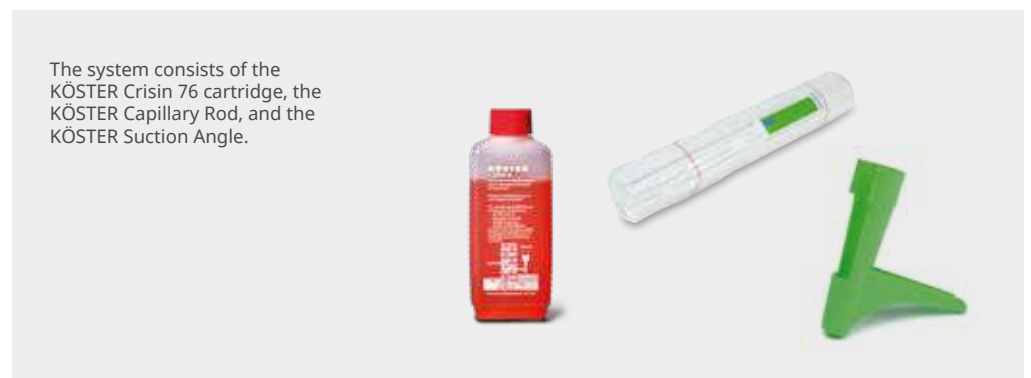
The patented KÖSTER Suction Angle System:

The patented KÖSTER Suction Angle System is the result of decades of experience and development work by the KÖSTER BAUCHEMIE AG. The horizontal barrier is distributed through the capillary transport itself, stopping the rising damp with its own physical cause.

The KÖSTER Capillary Rod acts like a wick, one end is inserted into the wall and the other end into the KÖSTER Suction Angle. From there, it draws the injection liquid into the wall. The KÖSTER Capillary Rod is available in lengths of 45 or 90 cm.

Schematic representation. Actual circumstances may differ in reality.

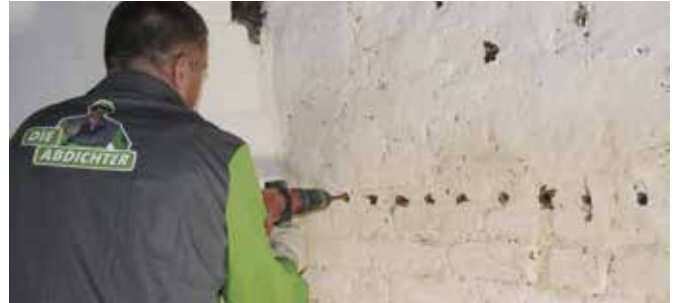
2 Boreholes are drilled into the inner wall with a distance of 10 cm from one another and depth of 40 cm (Wall thickness: 45 cm and 30 cm above grade).

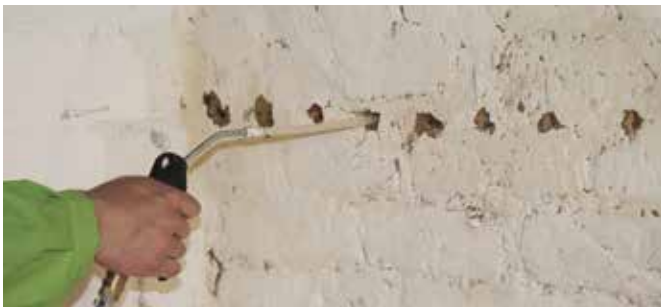
3 The boreholes are cleaned from dust by blowing the dust out of the borehole with pressurised air.

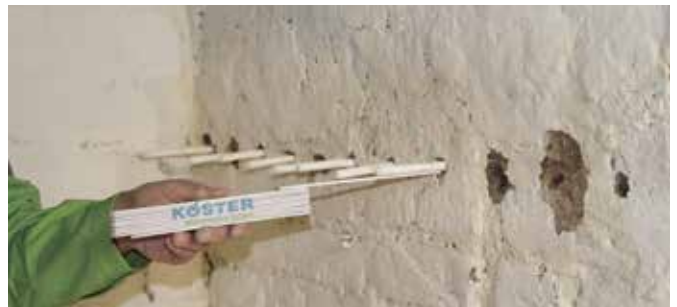
4 KÖSTER Capillary Rods are installed so that they protrude 7 cm from the borehole.

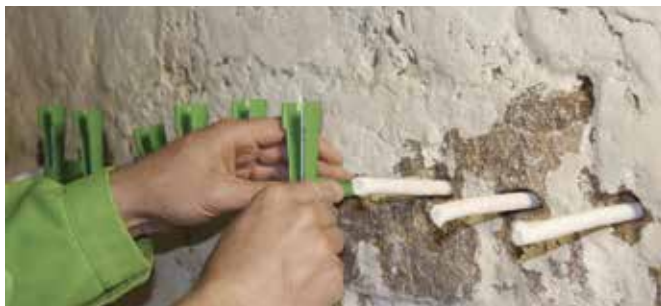
5 The KÖSTER Suction Angles are installed so that the KÖSTER Capillary Rods reach into the supply chamber of the KÖSTER Suction Angles.

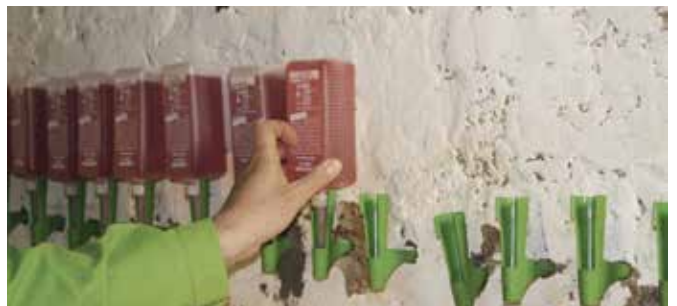
6 The KÖSTER Crisin 76 cartridges are then installed into the KÖSTER Suction Angle.

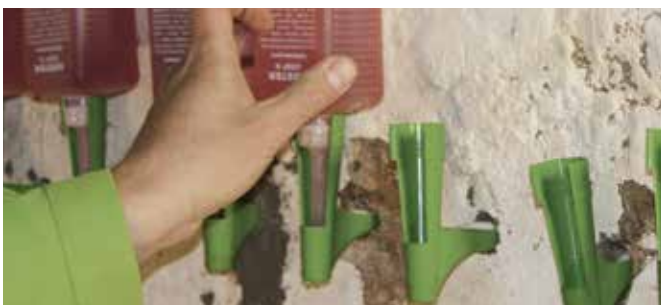
7 The nozzles of the cartridges sit directly on top of the capillary rod and allow the material to be soaked up.

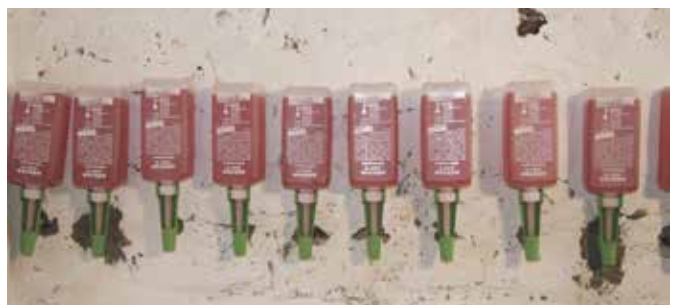
8 The pressureless injection of KÖSTER Crisin 76 into the masonry starts immediately after the installation of the cartridges.

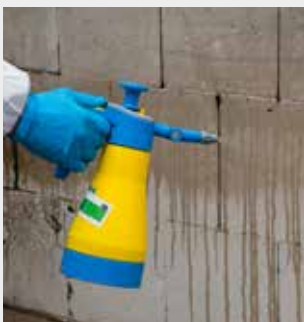
Remove old plaster. Fill breakouts and holes with KÖSTER Repair Mortar. Spray KÖSTER Polysil TG 500 onto the surface to block salts and strengthen the substrate.

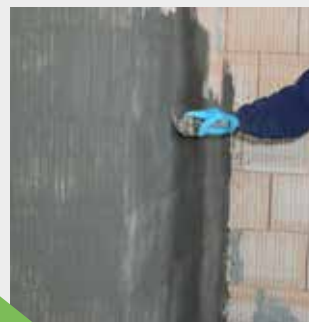
If negative side waterproofing is necessary, KÖSTER NB 1 Grey is applied in two layers.

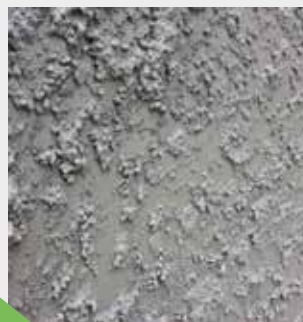
In the next step KÖSTER Restoration Plaster Key Coarse is applied to ensure the optimal adhesion of KÖSTER Restoration Plasters.

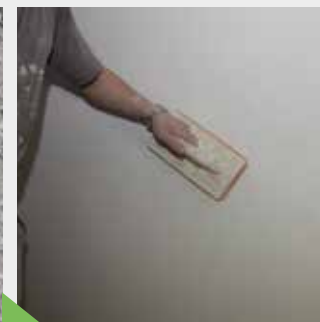
The KÖSTER Restoration Plaster is applied with a trowel or an appropriate mortar pump on the cured layer of KÖSTER Restoration Plaster Key Coarse. In the last step the surface is floated smooth.
